FIBER OPTIC CABLE VULNERABILITY TEST, WHITE SANDS, NEW MEXICO

By S. F. LARGE G. W. STYSKAL

DECEMBER 1982

Project No. 4940
Prepared by
THE MITRE CORPORATION
Bedford, Massachusetts
Contract No. F19628-82-C-0001

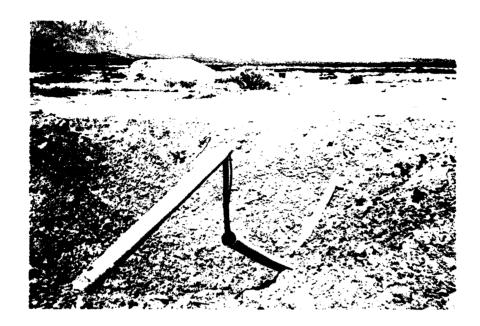
Figure 6. Conduit Separation

The results of this test proved most interesting. Unlike the first detonation in this three-shot series, the forces of the second blast threw the shallower conduit into disarray within the crater. From observations made after the blast it was found that several threaded conduit joints had "popped" apparently due to stresses that were generated. This failure of the threaded joints is believed to be responsible for the recorded failures of cables in some of the conduit. Stresses generated at positions B-3 and C-3 were estimated, from previous test data, at 4000 and 11,000 psi respectively. Ground accelerations at these positions were estimated to be approximately 5000 g's and greater than 5000 g's respectively. These forces made it easier to understand how the joint may have separated without even stripping the threads (see figures 6 and 7). It is speculated that the male end was compressed more than its surrounding female sleeve allowing it to pull free. The conduit separation put severe stresses, both shear and tensile, on the cables. Differing from the Fort Knox test of July 1981, 'none of the buried bare cables were exposed by the blast.

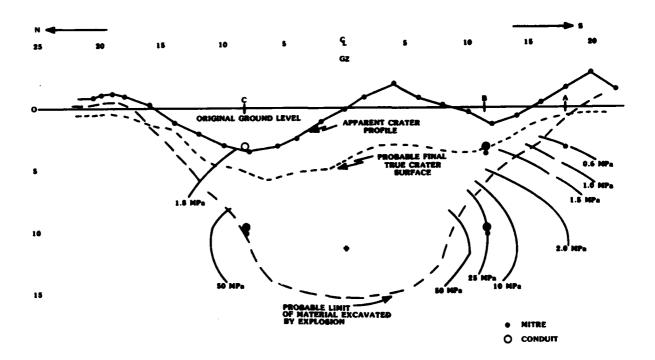
Figure 8. Crater Profile

The resultant crater from the detonation is illustrated in figure 8. Distances and depths shown are in feet. The ground stress contour lines are estimates based on previous tests. The composition of the soil in the area produces a central mount in all shots in this test series. Conduits in position B-1 and C-1 are displaced with such force that individual 10-ft sections project from the crater at very skew angles. It is also observed that the 110 m of trenching provide excellent earth anchoring for the cables. No cable motion was detected at reference points located at each end of the 150-m cables.

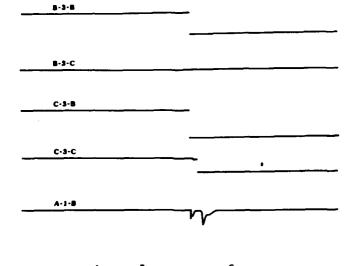
Figure 9. Dynamic Optical Throughput Measurement

which survived nor those that failed behaved exactly alike. While bare cables in positions B-3-B and C-3-B failed instantaneously, the protected cable in position C-3-C was damaged after a finite delay. The observed delay may be attributed to the initial separation of a conduit joint and the final break caused by excessive stresses which may have forced the separated conduit to shear the cable. Trench B provided the most valuable information. At the 3-m depth the bare cable was destroyed while the protected cable was unaffected. Position A-1-B shows a transient loss which could be related to both ground motion and crater ejecta fallout. Figure 9 illustrates the five strip chart recording mentioned above.

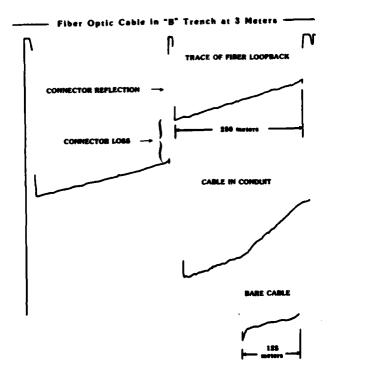
Figure 10. OTDR Trace Before and After Test Shot

The CTDR signatures made after the shot provide detailed information on cable failure locations as well as some insight into what form of break occurred. Figure 10 shows the trace for the two cables buried in trench B at 3 m. The cable in the conduit shows no signs of damage over its 250-m length. However, the bare cable is obviously broken at approximately 125 m, the location of the charge. Not only does the break appear, but it is evident from the left-hand end of the trace that the localized drop in signal represents a stressed area of fiber. This condition may be manifested by high tensile forces on the cable.

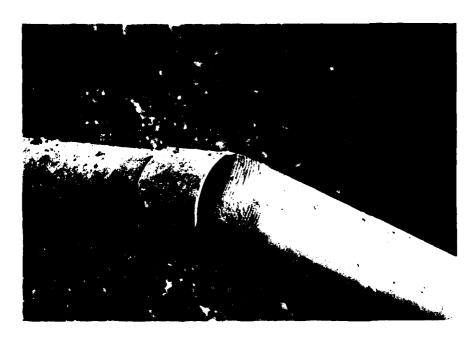
Figure 11. Vertex Formed by Conduit Separation

A differential attenuation in cable B-1-C was caused by a localized stress point created by the upheaval of the B-1-C conduit. The conduit was disconnected at all three of its joints with the middle two sections forming a triangle (shown in figure 11) sticking up out of the crater about 3 to 4 feet. The vertex of this triangle formed a sharp edge with the end of one section jammed into the opening of the next one. The cables were all somewhat pinched and under a great deal of tension. The combination of the tensile stress and the sharp edge caused the final attenuation. Upon closer examination, it was found that the outer jacket and some of the underlying KEVLAR had been cut rather deeply by the jammed conduit. Despite this severe outer jacket damage, the optical link was still operational even with the induced attenuation.
